AN OASIS FOR RAILROADERS IN THE MOJAVE
The History and Architecture of the Los Angeles and Salt Lake Railroad Depot,
Restaurant and Employees' Hotel at Kelso, California, on the Union Pacific System

Kelso Depot Historic Structure Report

National Preserve • California

January 1998

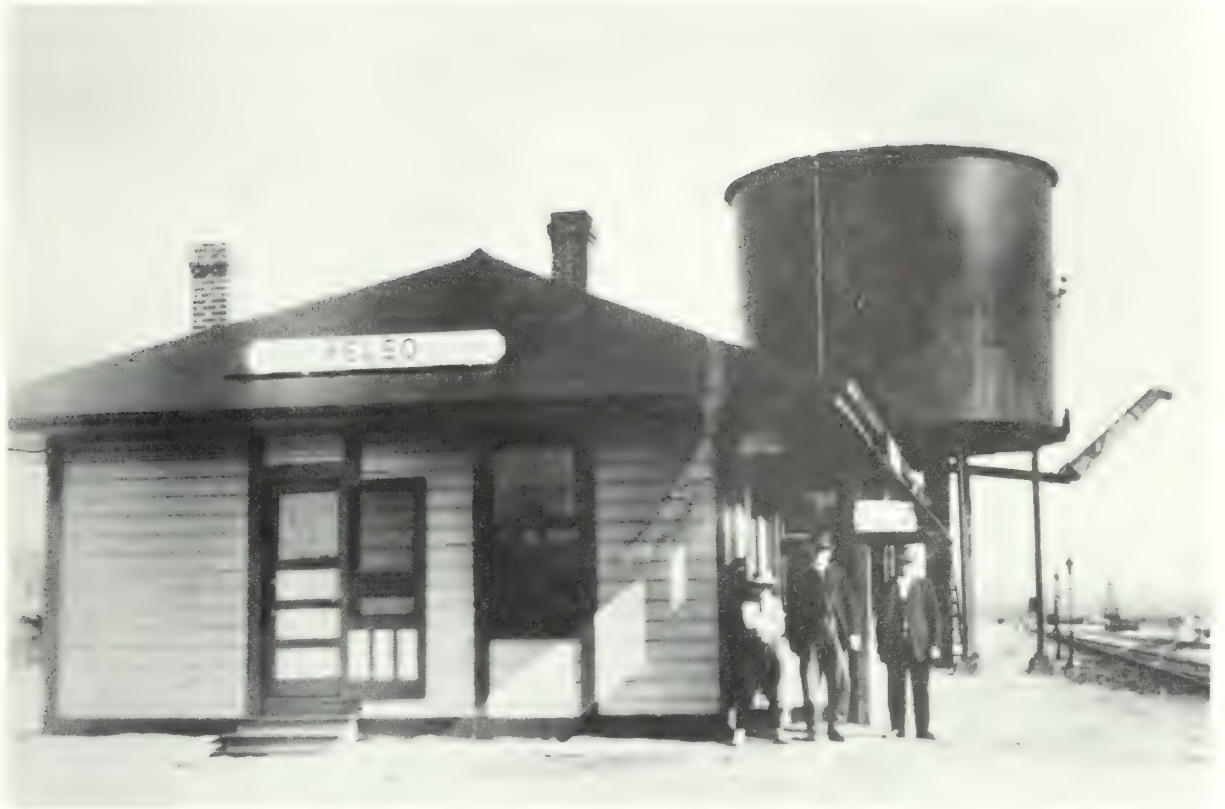
Photo 4: The original depot at Kelso, California, built in 1905, was moved farther eastward along the track in 1923 (northeast in compass direction) and became first the Station Agent's Residence, and later the Roadmaster's Office, in order to make room for a new Kelso depot. Steele's Photo Service, courtesy Dennis Casebier.

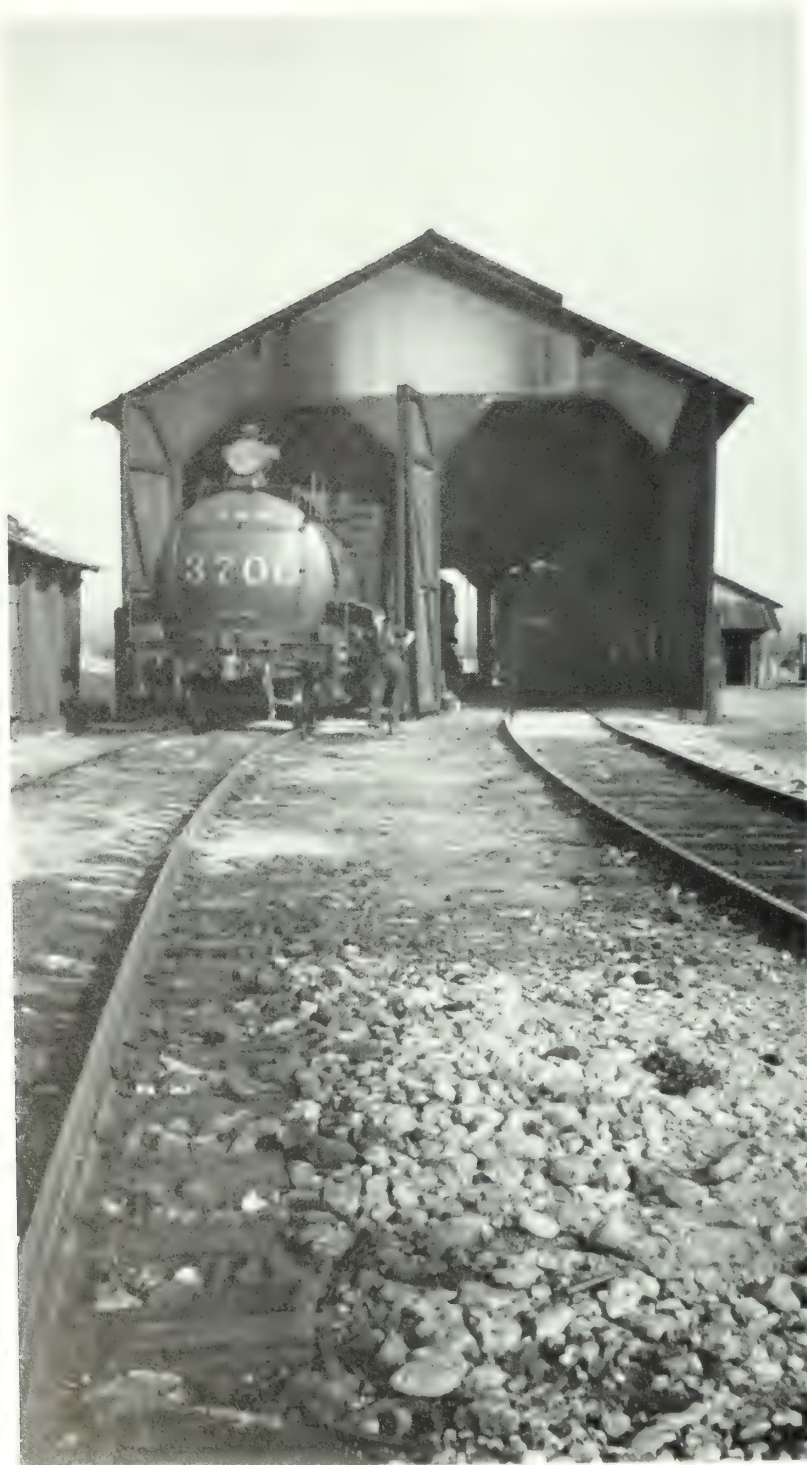
Photo 5: The original corrugated iron on wood frame two-stall engine house built in 1905. Two more stalls were added ca. 1921. Then ca. 1922-23, it was torn down and replaced with a five-stall concrete roundhouse with radial tracks and ladder switches (no turntable). Photo probably by Lester Packard, courtesy collection of Theo Packard.

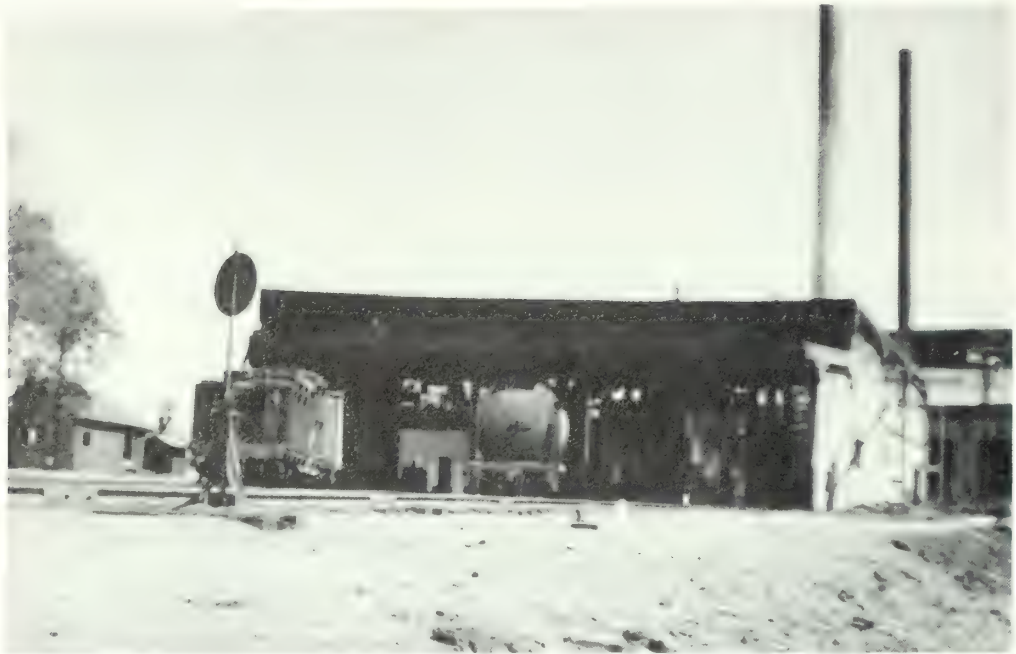
Photo 6: Kelso roundhouse, built ca. 1922 or 1923, a five stall concrete structure to the east of the Depot. This "roundhouse" did not have a turntable; locomotives turned on wye tracks. The structure was demolished in 1948. Behind the roundhouse at right is the powerhouse. Photo courtesy collection of Art Francis.

Given initial approval by the Executive Committee that same day, its official approval date by the committee was June 20, and it was approved by the Board of Directors of the Los Angeles & Salt Lake Railroad on September 14, 1922. The new concrete roundhouse, its stalls accessed like those of the old one by a succession of turnouts (ladder switches) rather than by a turntable, apparently was built in late 1922 and early 1923. As Kelso had wye tracks just to the northeast of the new roundhouse, it had no need for a turntable on which to turn locomotives around.²⁷

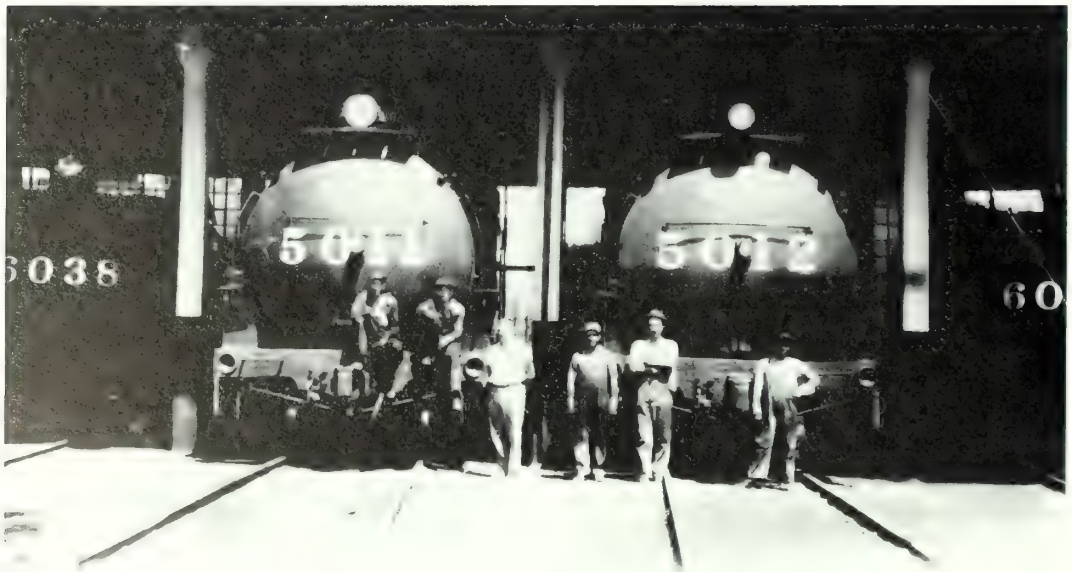
Photo 7: A portion of the five-stall roundhouse with mechanical department employees (machinists, boilermakers, etc.). Photo courtesy collection of Art Francis.

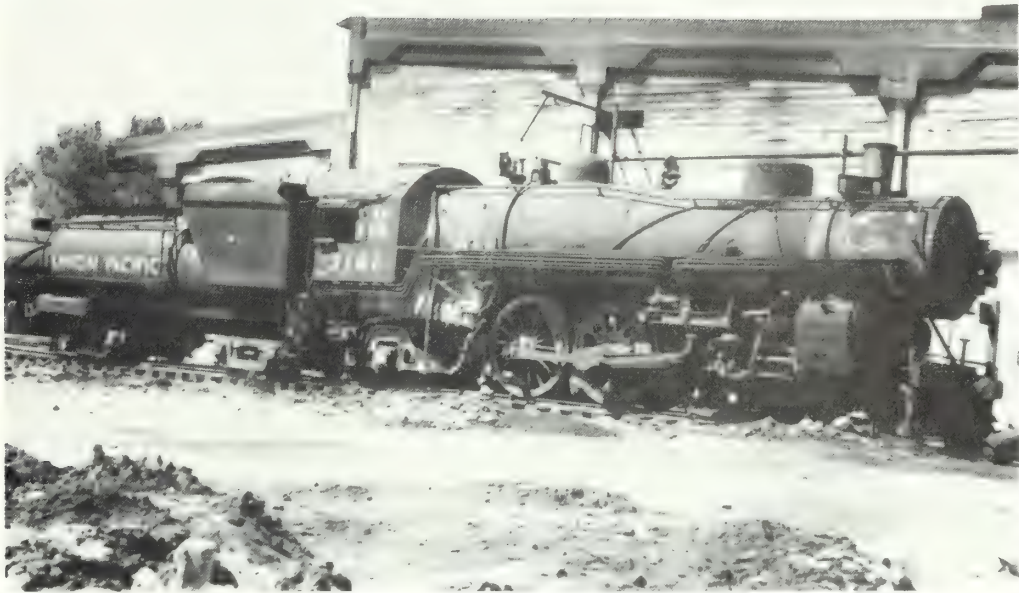
Photo 8: A 4-6-2 locomotive, Union Pacific No. 3181, built by Schenectady in 1912, alongside the Kelso roundhouse, probably during the 1930s. Photo courtesy collection of Art Francis.

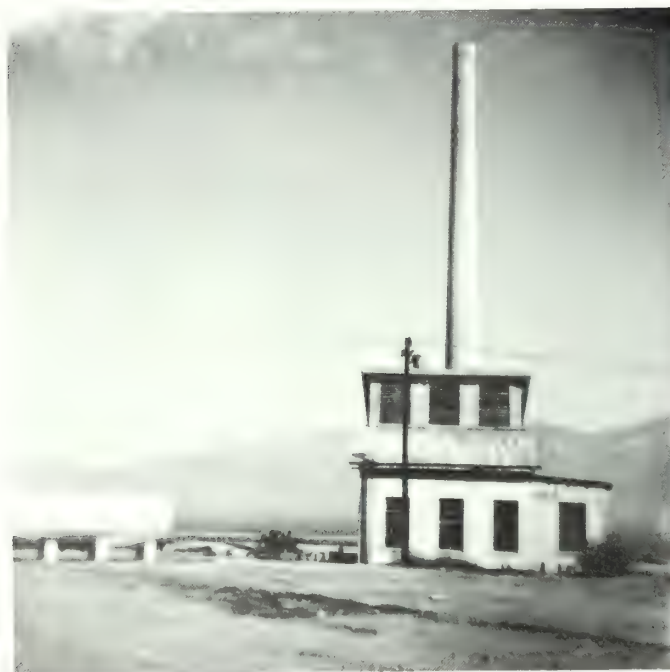
Photo 11: Power house and smokestack. The stack remained until the late 1970s or 1980s. Photo 1950s courtesy collection of Art Francis.

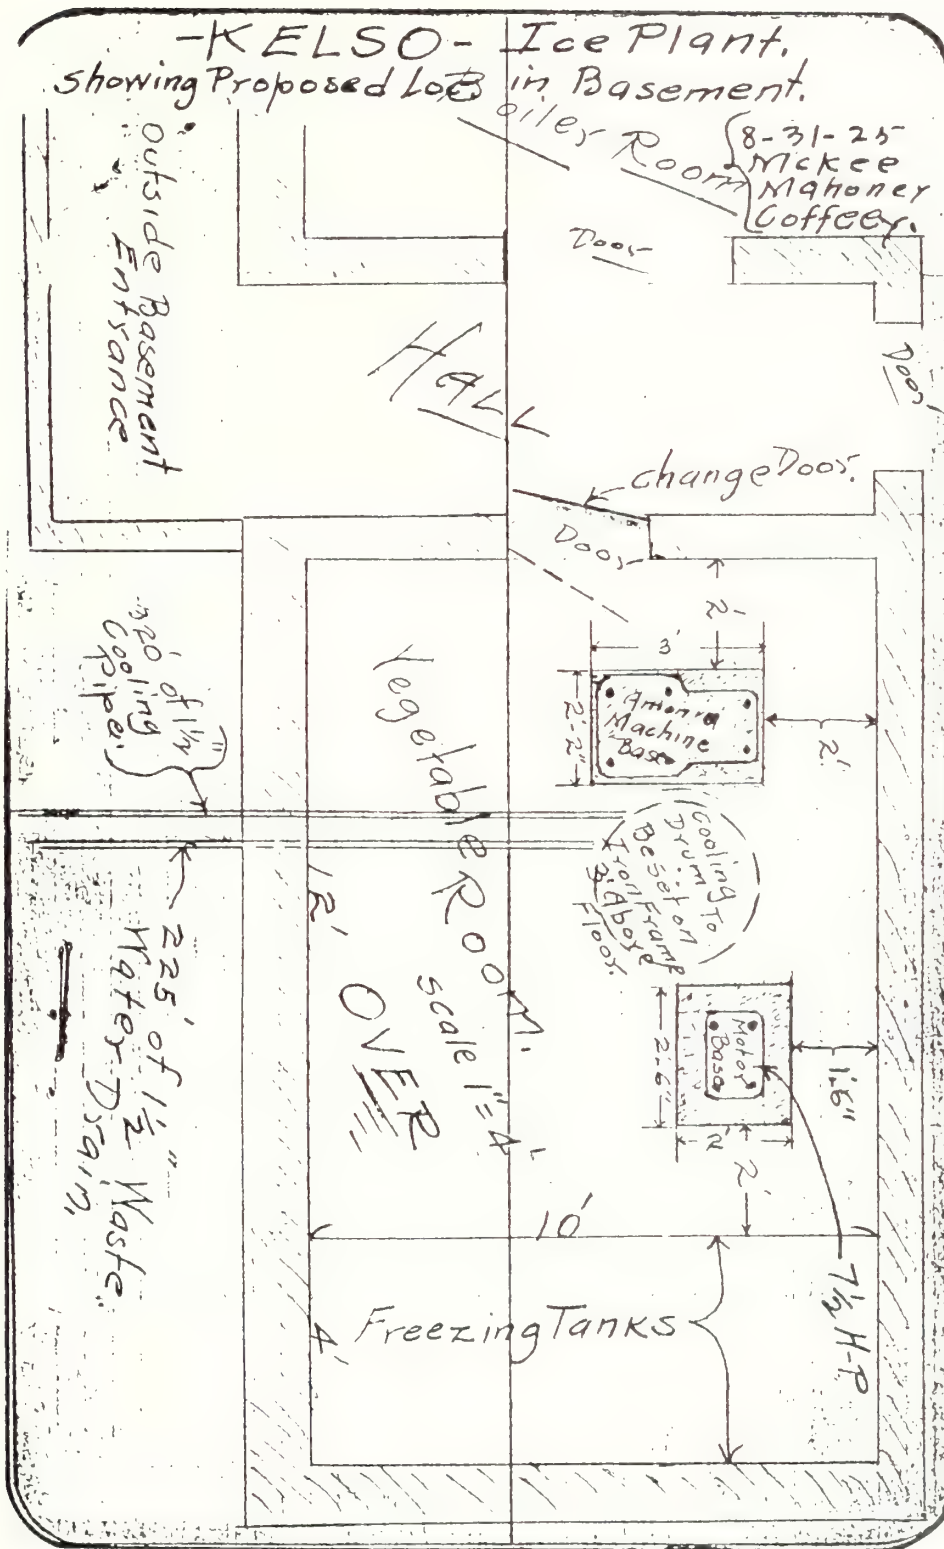
Figure 1: Field Engineers's drawing of August 31, 1925 showing a proposed location for an ice plant in the basement of the depot. It identified the room as the "Vegetable Room" which is the "Storeroom" shown on the 1924 as-built drawings. Credit: Union Pacific Museum Collection.

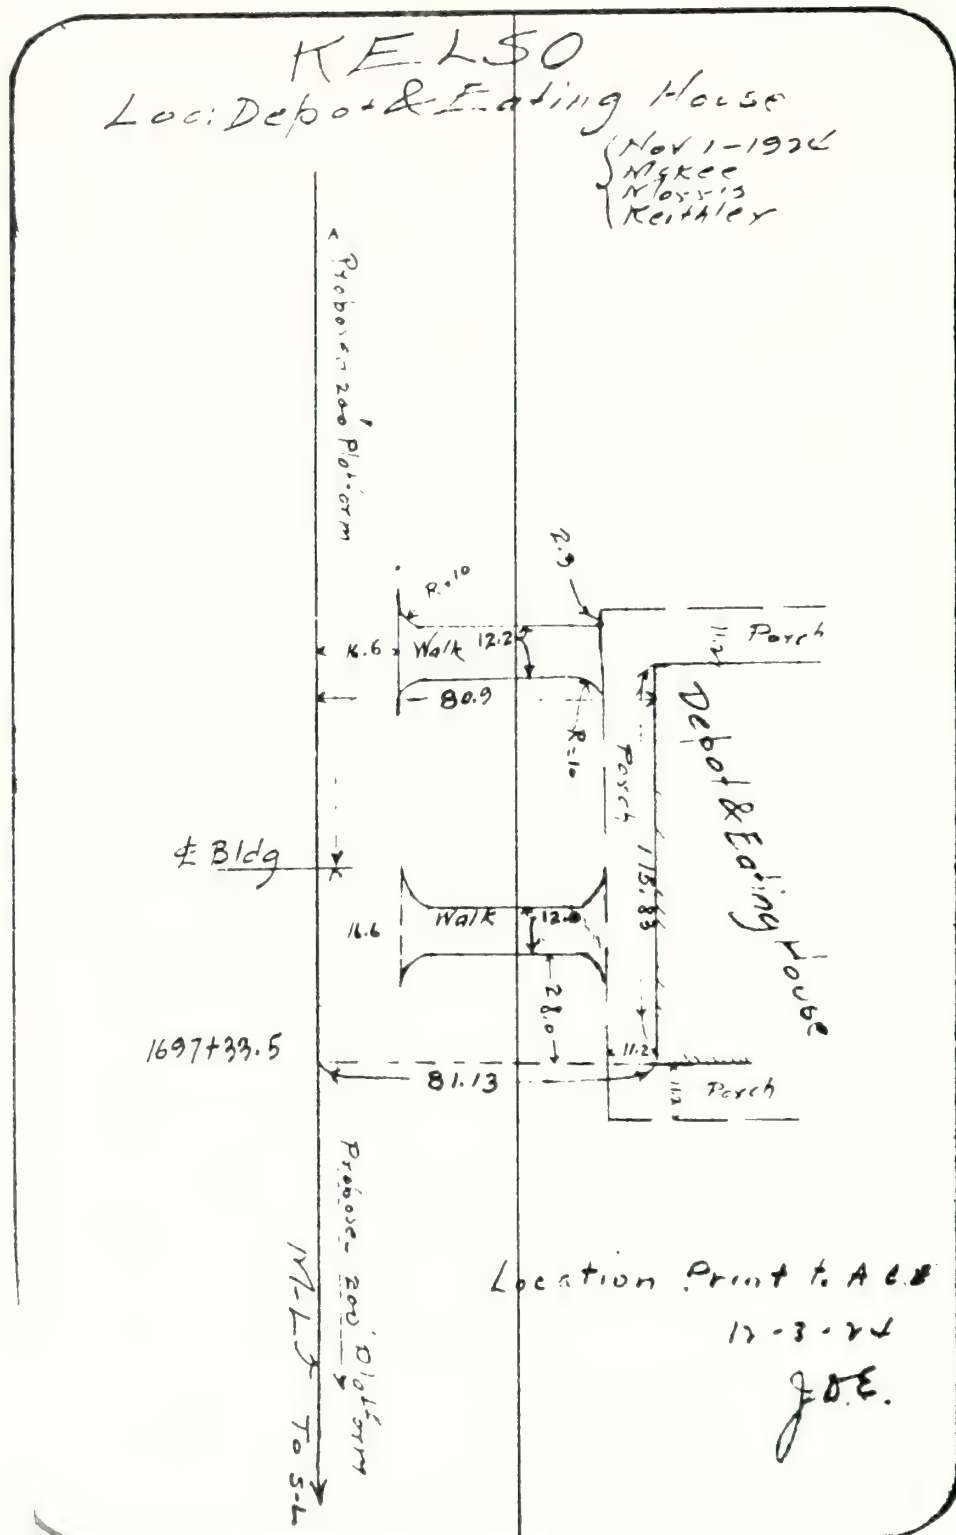
Figure 3: Field Engineer's drawing, Nov. 1, 1924, showing the new vitrified brick walks connecting the depot arcade with the not yet built station platform. A location print was sent to the Assistant Chief Engineer on Dec. 3, 1924. Credit: Union Pacific Museum Collection.

feet wide, only the east one being 12.0. A copy of this location print went to the Assistant Chief Engineer in Los Angeles on December 3, 1924.⁶⁴

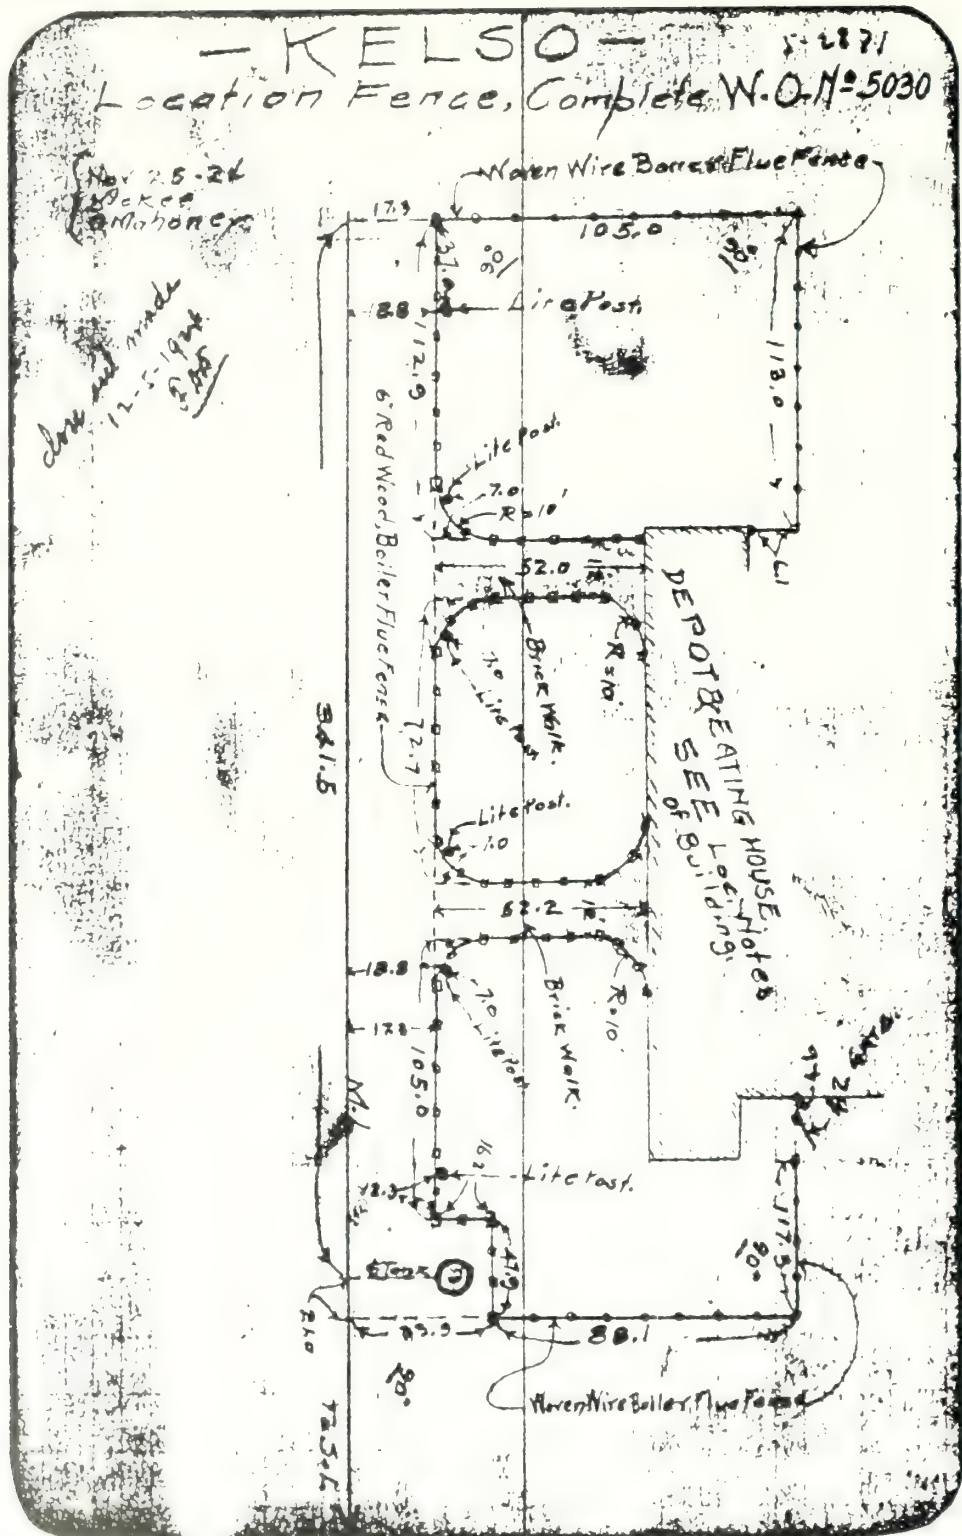
Figure 4: Field Engineer's drawing, Nov. 25, 1924, of the depot fences which had been built under Work Order No. 5030. The front fence consisted of six-inch square redwood posts with beveled tops, drilled for a pair of rails of used boiler flues from locomotives. To the east and west of the lawn area and building, the fencing was of woven wire on boiler tube posts. The work was closed out December 5, 1924. Credit: Union Pacific Museum Collection

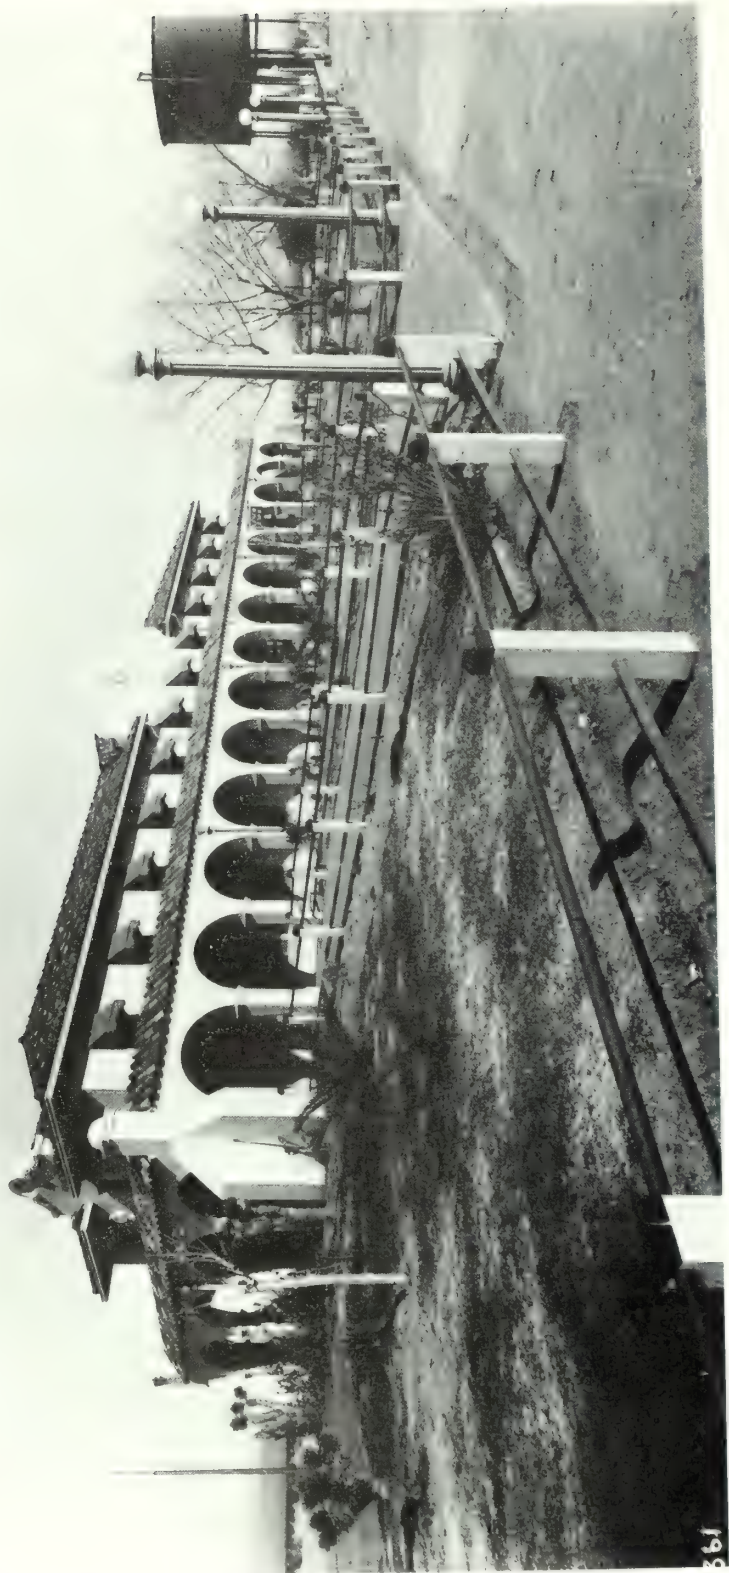
Photo 15: "Kelso Club" - Depot, Boarding and Rooming House, Kelso, California, ca. fall 1924. Note the boiler tube and redwood post fence, the brick walks from the building to the asphalted gravel station platform, the light posts with spherical globes and the water tank at the far right. Credit: Union Pacific Museum Collection, Nos. 501857 and 501518.

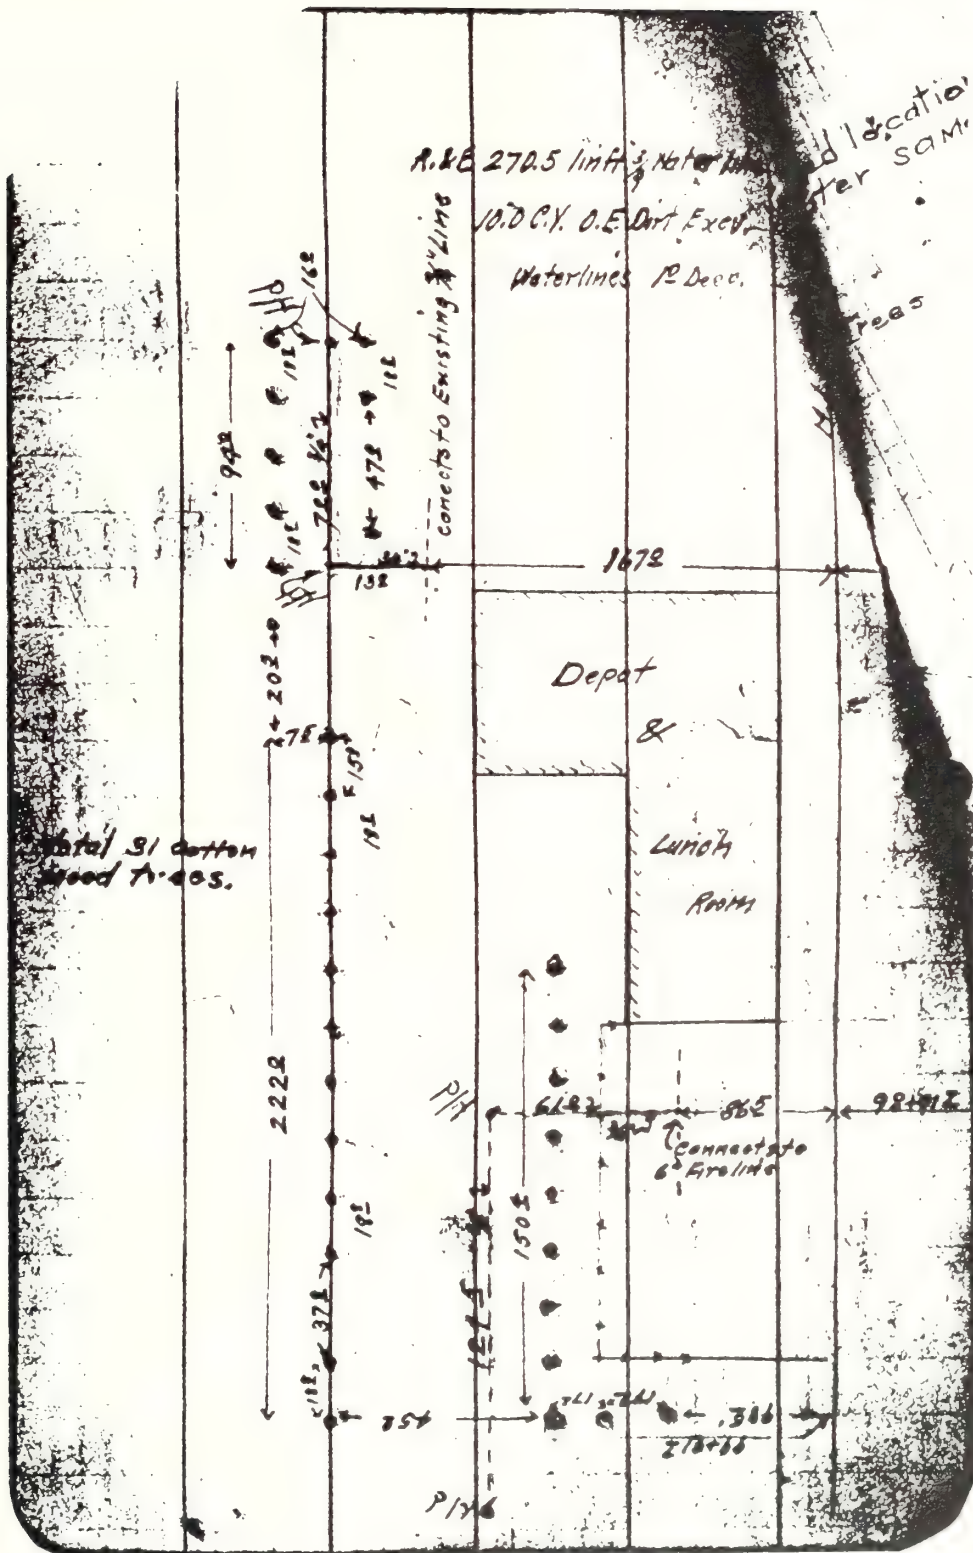
Figure 5: Field Engineer's drawing showing a sprinkler system apparently intended to water a group of cottonwood trees behind the depot. This may have accompanied another drawing of July 26, 1929. Credit: Union Pacific Museum Collection.

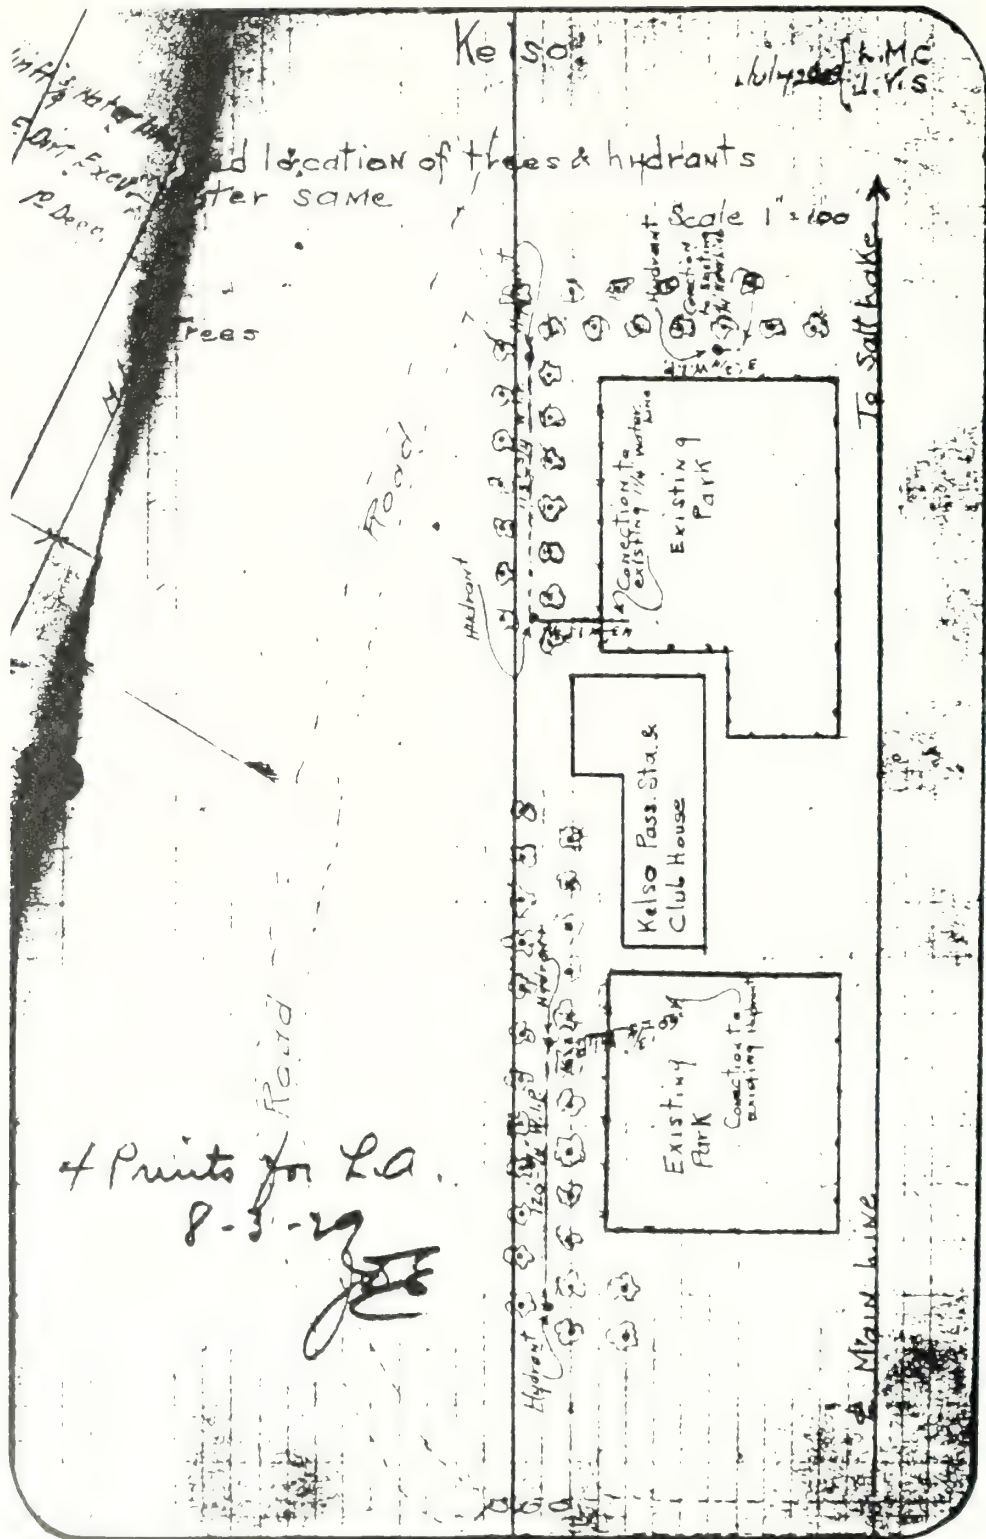
Figure 6: Field Engineer's drawing dated July 26, 1929 showing cottonwood trees behind the depot and lawn areas. Four prints were sent to railroad headquarters in Los Angeles on August 3, 1929. Credit: Union Pacific Museum Collection.

two rows at the east end. From the easternmost tree of the fourth row, six more trees stood in a straight line at right angles extending along the east side of the depot building and lawn to the vicinity of the station platform to form a sixth row, or, if one preferred, it could be called a continuation at right angles of the fourth row. From the tree at the extreme east end of the fourth and fifth rows, offset between them, three trees, then a space, then a fourth tree, marched parallel to the sixth row to form a seventh row, or if one preferred, a continuation of the fifth row at right angles, toward the depot platform, but terminating short of it. What species were included in the fourth, fifth, sixth and seventh rows is unclear. Furthermore, the date all the trees, cottonwoods and others, were planted is unclear, as the field engineer's notes of August 1929 showed both the trees and a new 3/4-inch water line laid one foot deep behind the depot and its grounds to water them, and it is not clear whether the purpose of the drawing was to document completion only of the water line among already existing trees, or both construction of the water line and planting of the trees. What is clear is that by July or August 1929, the railroad had cottonwood trees and other trees in rows behind the depot and along its east side, a total of 52 trees, and planned or had already built water lines to irrigate them. The trees may have been intended to provide a windbreak behind the depot.⁸¹

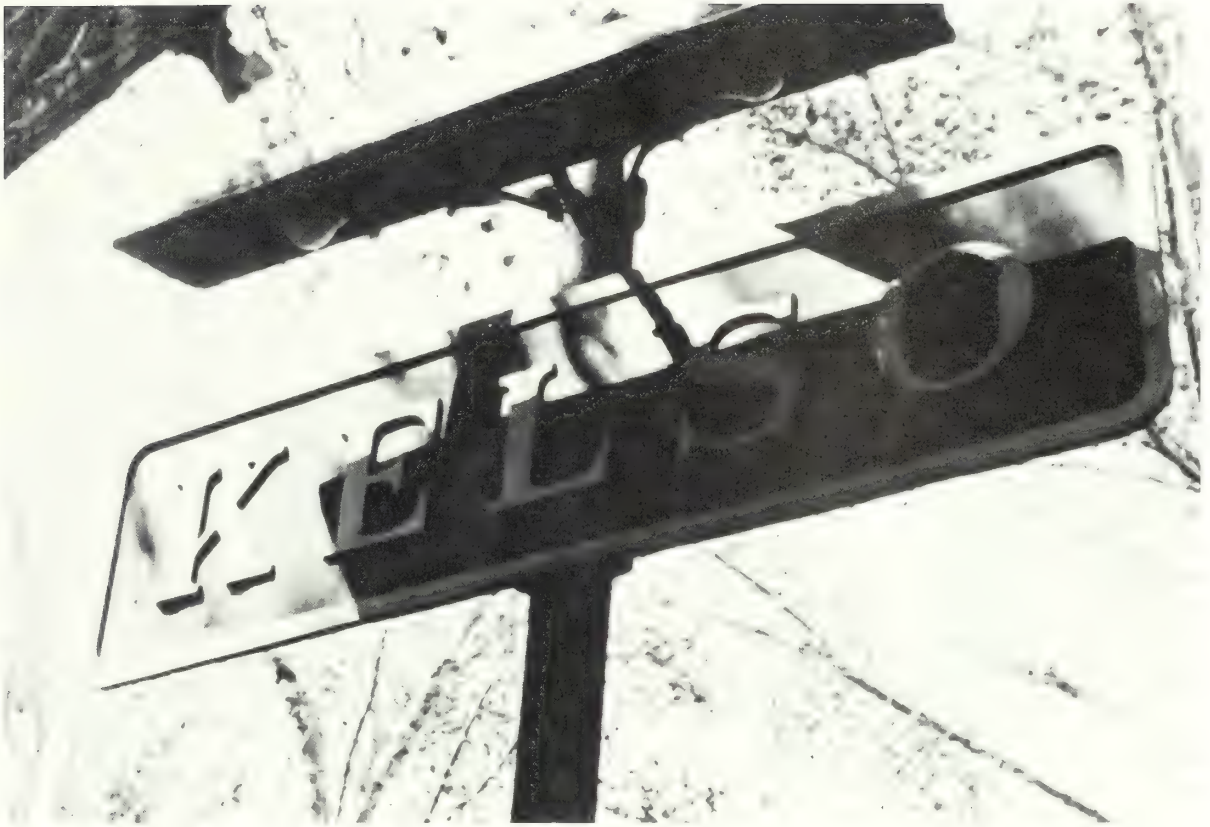
Photo 17: One of two illuminated Kelso signs erected on the Kelso Depot grounds, both now gone, except the steel base of the west light still exists. Credit: San Bernardino County Museum.

85. Undated Field engineer's note, without name of field engineer(s) or title, from the context in the group of notes of . . . it was a part probably prepared during the late 1920s, supplied by the Union Pacific Railroad Museum. An accompanying note shows the western sign 65.7 feet from the center of the main track directly opposite engineering station 1699+06.0 and eastern sign 66.6 feet from the track center at station 1696+78.0.

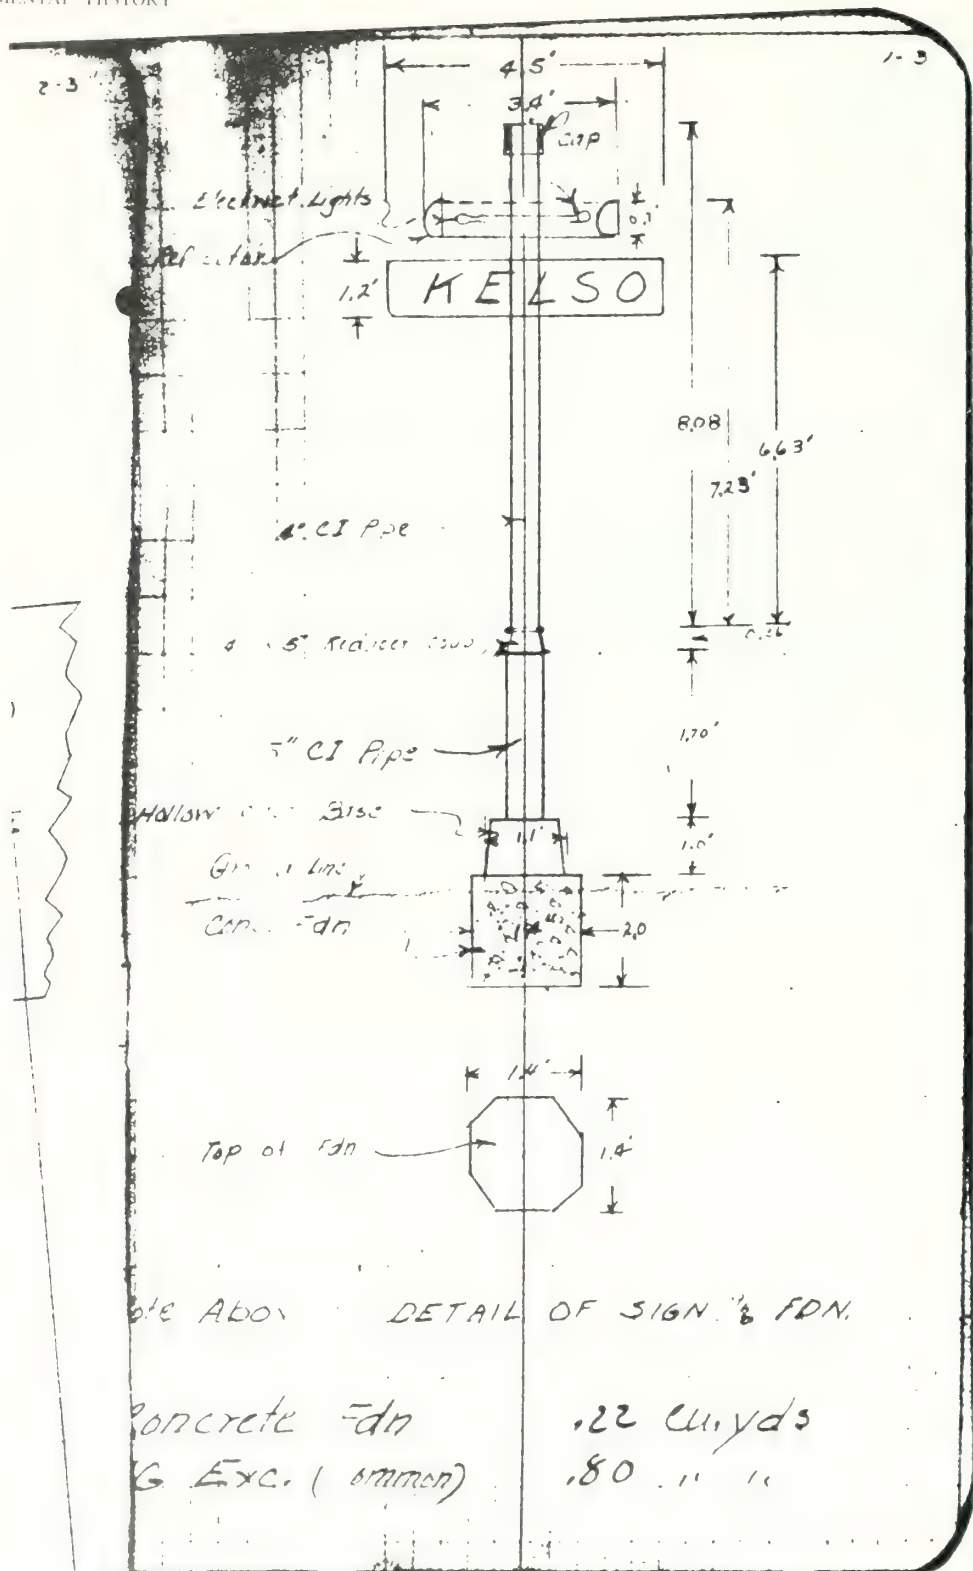
Figure 7. An undated field engineer's drawing probably from the mid or late 1920s of a lighted sign for the depot grounds. Credit: Union Pacific Museum Collection.

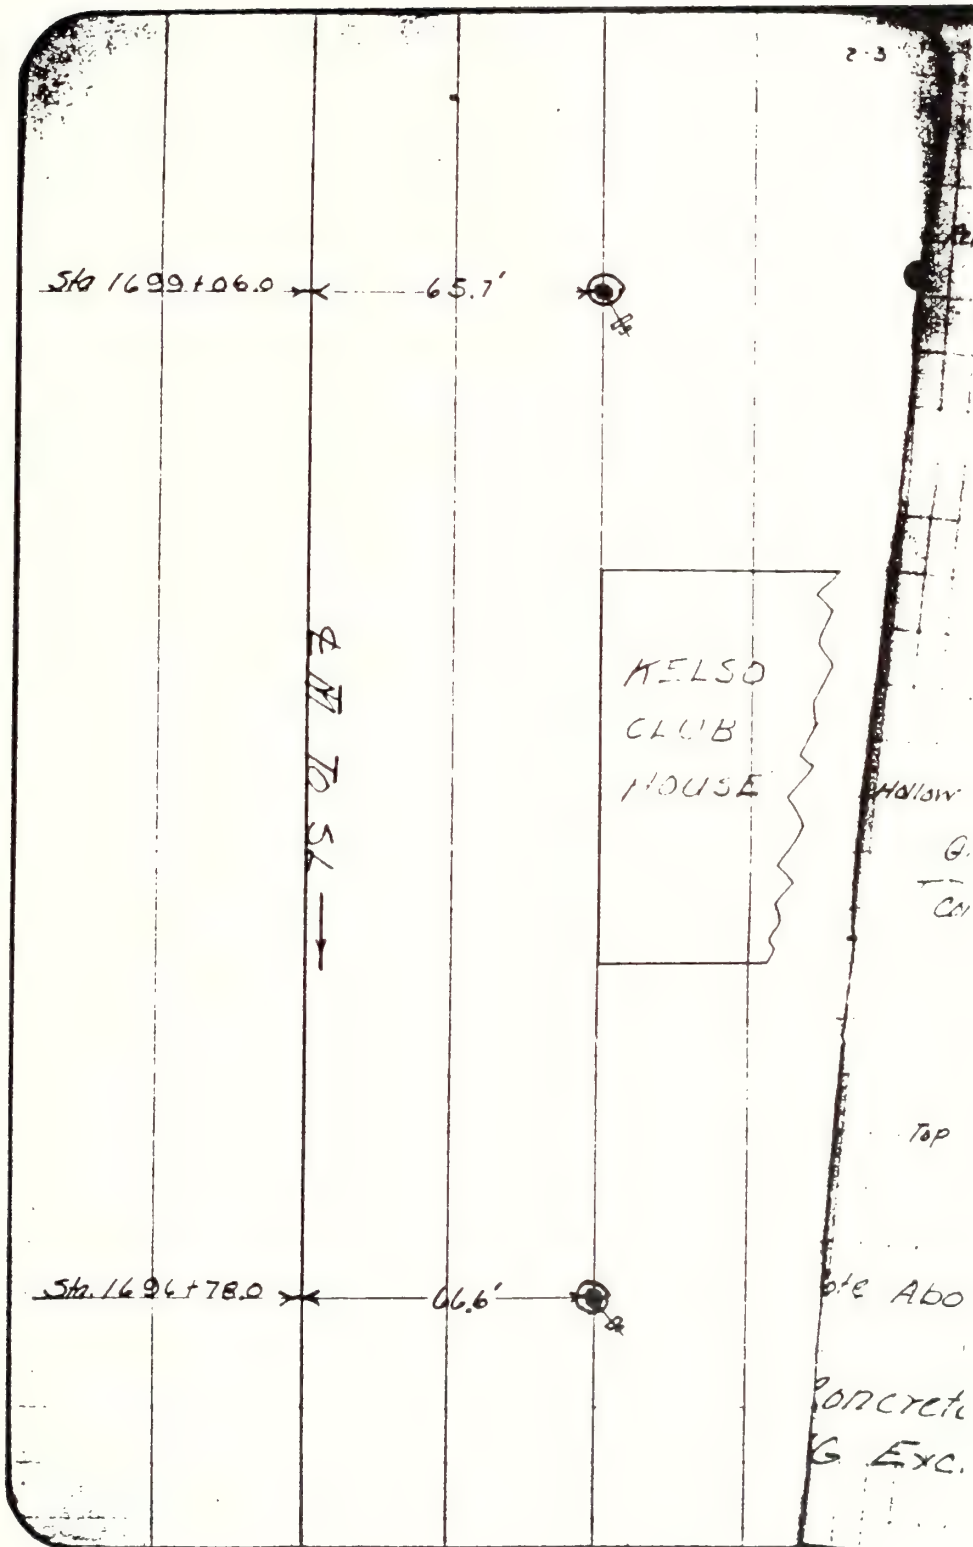
Figure 8: Undated field engineer's sketch showing the locations of the illuminated Kelso signs on the depot grounds. Credit: Union Pacific Museum Collection.

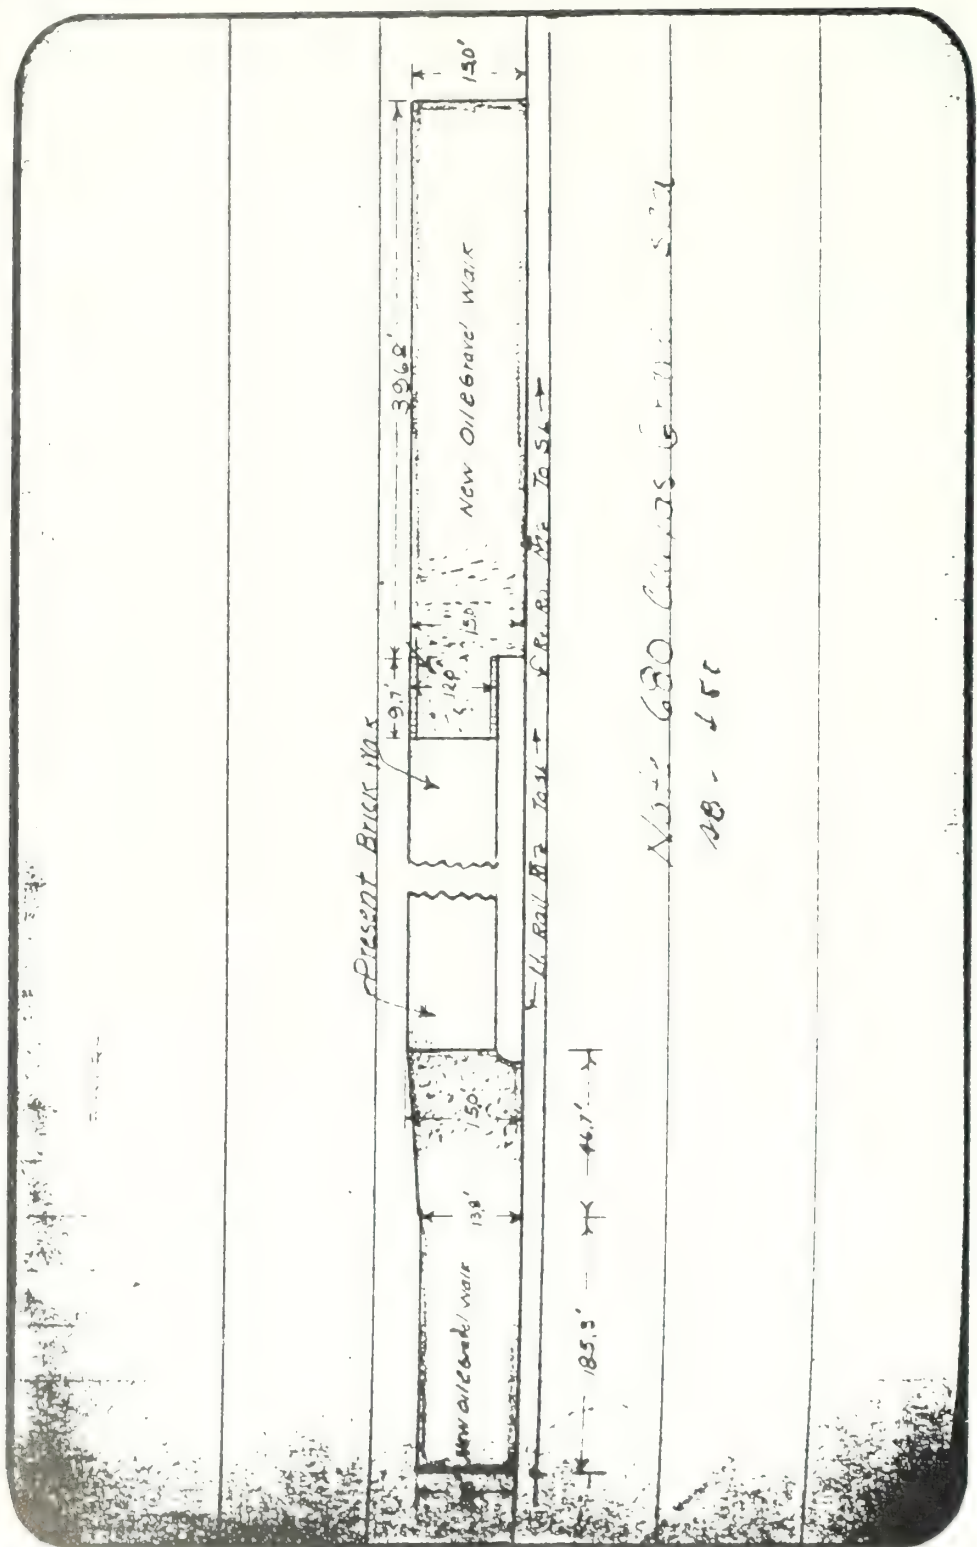
Figure 9: Undated field engineer's sketch showing oil and gravel extensions of the brick station platform. These extensions later became concrete. Credit: Union Pacific Museum Collection.

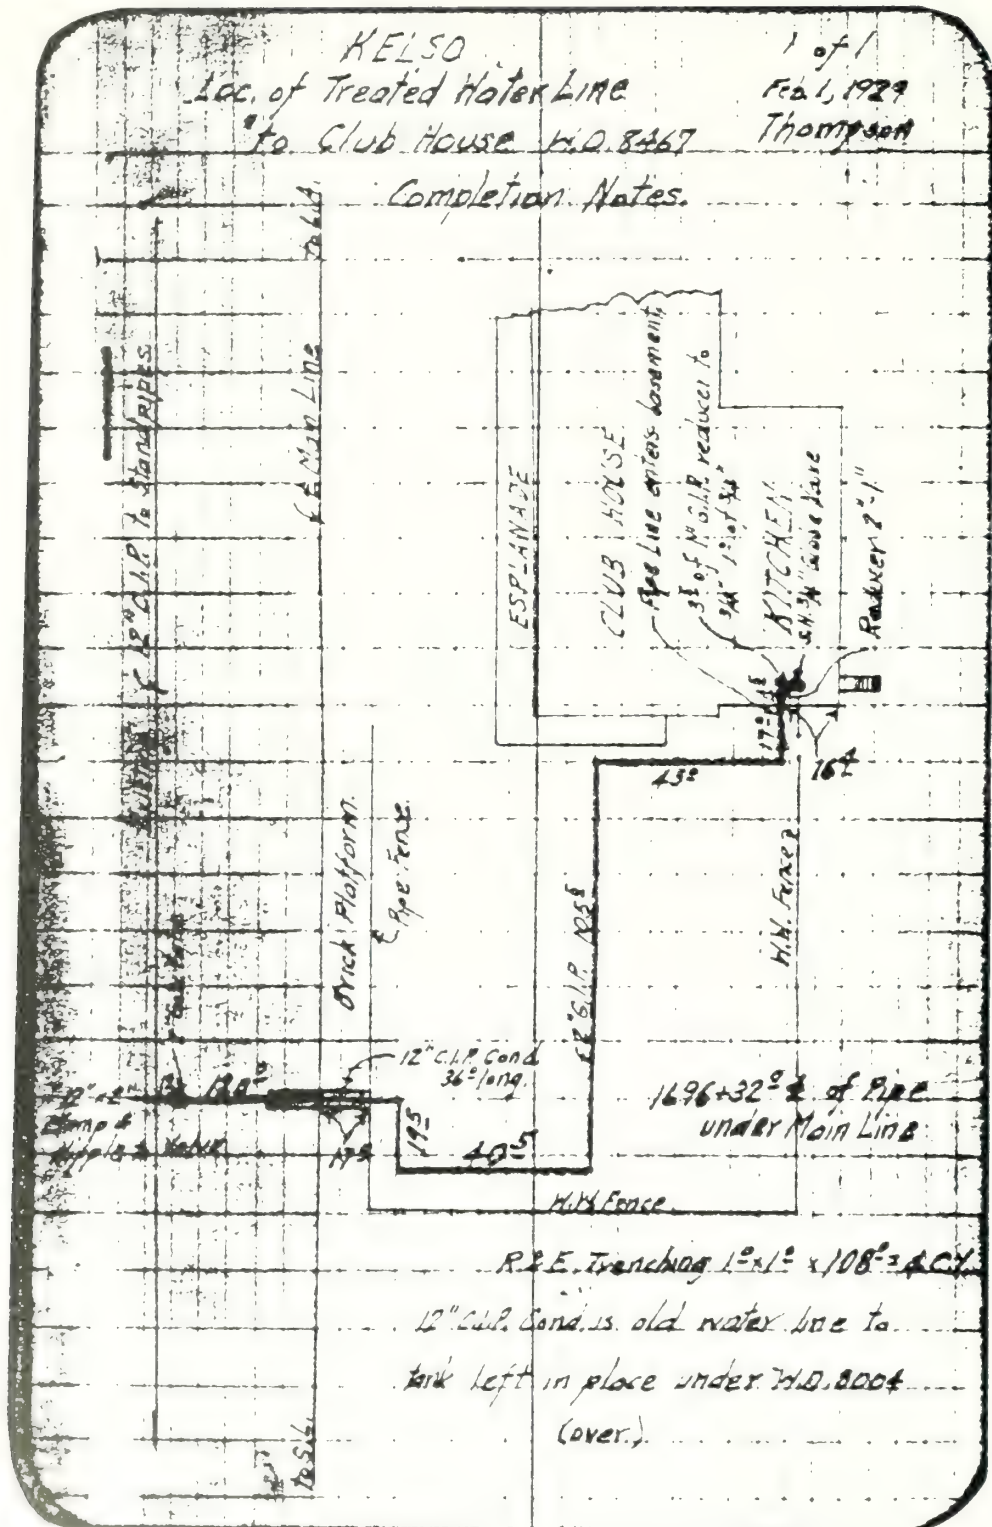
Figure 10: Field engineer's sketch, February 1, 1929, showing water line work at the depot; also indicating some of the brick platform and fences. Credit: Union Pacific Museum Collection.

On February 1, 1929, a Salt Lake Route field engineer named Thompson drew up "Completion Notes" for the "Loc[ation] of [a] Treated Water Line," i.e., a pipe line to carry water treated for drinking, cooking, and other domestic use, to the Kelso Depot kitchen. The line came from a treatment plant south of the tracks, passed beneath them and presumably beneath the brick station platform and pipe fence, then extended 17.5 feet at right angles from the centerline of the main track, turned east for 19-1/2 feet, then north for 40-1/2 feet, then southwest parallel to the tracks for 105-1/2 feet, then just short of the depot collonade on the east end of the building, turned northwest parallel to the northeast end of the depot for 45 feet, then turned southwest and ran 17-1/2 feet to the wall of the depot kitchen where it entered the depot basement beneath the kitchen. The railroad completed this under Work Order No. 8467.⁸⁸
